IC-706 (Mk 1) FM Transmit Fix

by Adam Maurer, VK4CP

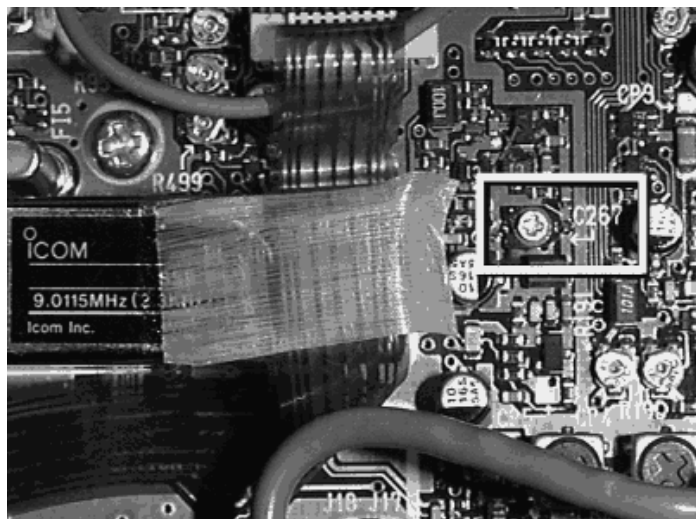
The main board of the IC706 showing C267

I discovered that C267 (a miniature SMT trimmer capacitor located – see picture - 9mm to the right of the 9.0115 MHz IF Filter on the Main Unit) was not reflowed to the PCB to a satisfactory standard. There was insufficient solder paste applied during the printing process, the end result being an intermittent solder joint and an unlocked 9 MHz VCO.

After re-touching both pins of C267 with fresh solder it's performed faultlessly since. Although access to the offending area is easy you will need a very fine tip on your iron to get to the pin on the filter side without damaging the cap and disturbing two nearby 0603 chip capacitors.

5. Locate 9.0115 MHz IF filter and then locate C267 (identified on silk-screen)
6. Using fresh solder, carefully re-touch up solder joints to both pins of the trimmer cap. The filter side is difficult due to nearby capacitors and the fact that the ground plane sinks a lot of heat.

It is unlikely you will need to tweak C267. The setting is not that critical, just set it in the centre of the lock range.
